## PILOT'S FLIGHT REPORT

PILOT: E.F. Schoch  
DATE: 22 October 1948  
FLIGHT NO: 524-5  
WEATHER: CAVU  
PROJECT: XF-85  
FLIGHT TIME: 36 minutes  
PURPOSE: Hook-on practice and check on directional stability.  
WEIGHT AND C.G. 5900 lbs; 22% MAC  
CHANGES SINCE LAST FLIGHT: Hook-fairing removed.  
CONFIGURATION: Belly skid attached.  
INSTRUMENTATION: Standard Flight Test  
ALTITUDE AND PROCEDURES: At about 20,000' P.A. and 185 mph IAS feel out directional control while attached to the trapeze. Release if satisfactory, check directional control at 185 mph and hook-on. Release and perform measured yaws at 200 mph with the hook up and down. Check longitudinal trim and control up to about 300 mph IAS.

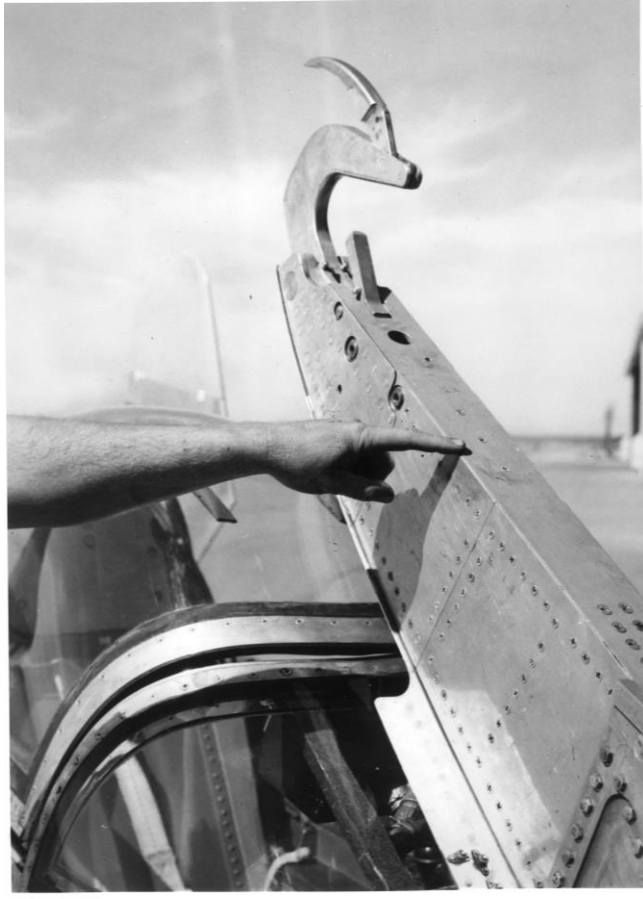
D4E-13117 XF-85 POINT OF CONTACT WITH TRAPEZE BAR DURING ATTEMPTED HOOK-ON.

7. The airplane was then flown back into formation and another attempt made to hook on with no improvement. The airplane was difficult to control laterally or possibly directionally inasmuch as it had a tendency to go from one side to the other. The attempt finally ended up with considerable power on, a little high and fairly close to the bar. Forward stick was applied with the hope of catching the hook. This was partially successful in that contact was made with the front portion of the hook which broke due to the high rate of descent at the time of contact.

5. Relocation of the trapeze bar to a clear air area should reduce the longitudinal and power control problems as the bar is approached. Also, redesign of the hook and trapeze to more flexible structures would aid the power control problem as well as reduce the requirements on the pilot since he would have a feeling of more latitude for hook-on, rather than aiming for point to point contact with practically zero speed differential.

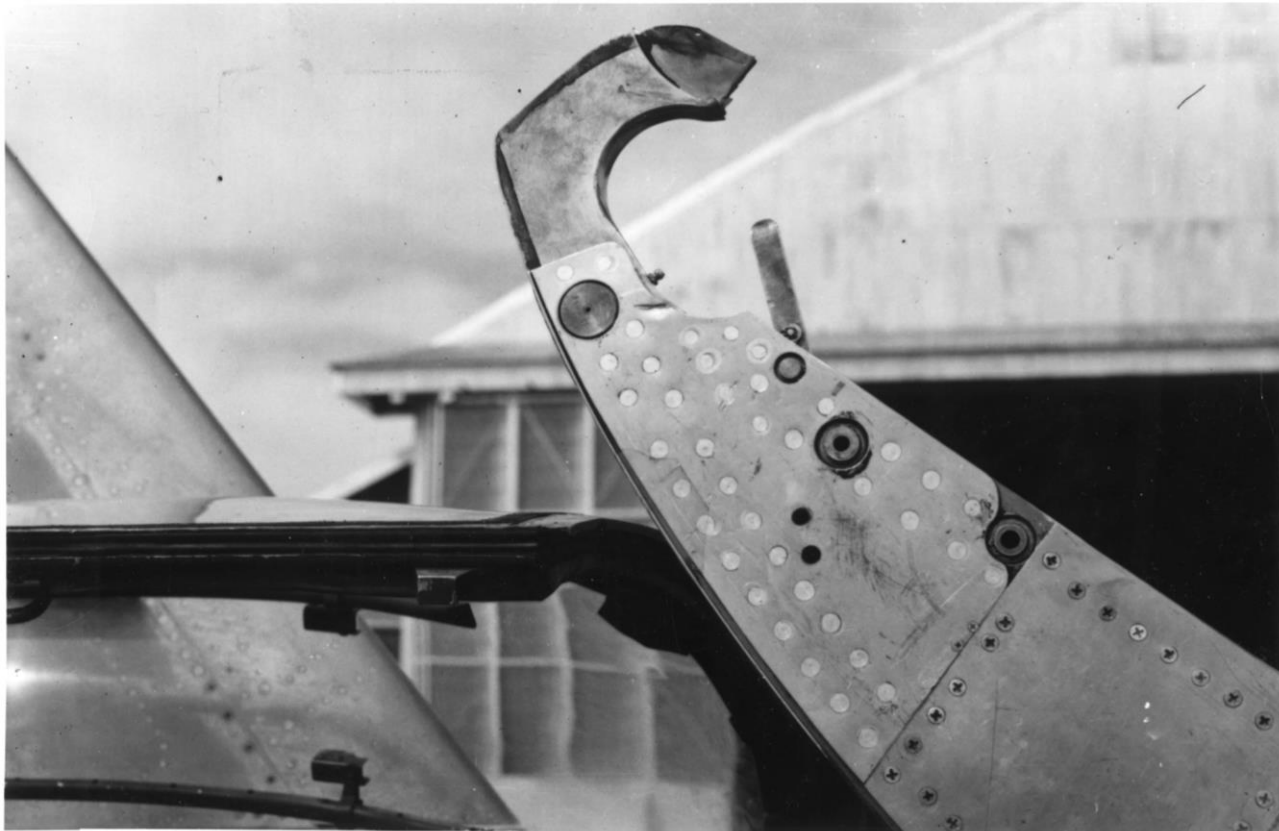
XF-85 DAMAGE TO SKY HOOK HEAD FIT. 524-5
